Several cases of backward erosion/liquefaction piping from Hungary

E. Imre

BSTRACT: Some cases of backward erosion/liquefaction piping are described. These distinguish between usual sand boils and the ‘fast’ piping, the - possibly dynamic liquefaction induced – breach. The latter happens in a matter of minutes, whereas in the former emergency response measures can be effective.

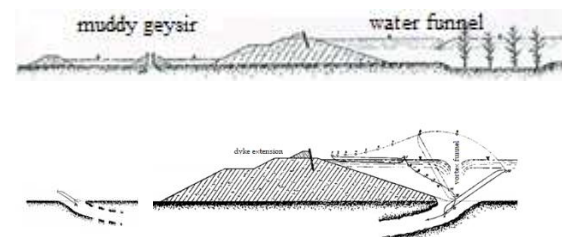
Figure 1. Illustration of the boat diving to the pipe in 1926, (a) condition some minutes before breach, (b) the path of the boat, which ended on the safe side at around the first sand-boil spot.

20 meters, the boat suddenly began to tilt into the vortex, his nose up and made the path dived under water and reached the other side of the dyke Fig. 6.

When the vortex water funnel - constantly approaching the embankment - was 15-20 meters away from the crest, the boat suddenly began to tilt, his nose staring at the sky and made a path marked with numbers while diving under the water. The boat appeared on the other side of the levee. Subsequently, the crest began to crack, the embankment settled to a length of 8 to 10 meters, the water began to flow into the saved area, and the dam breach soon widened to 80 to 100m. The depth of the washout was 24 meters below the flood level

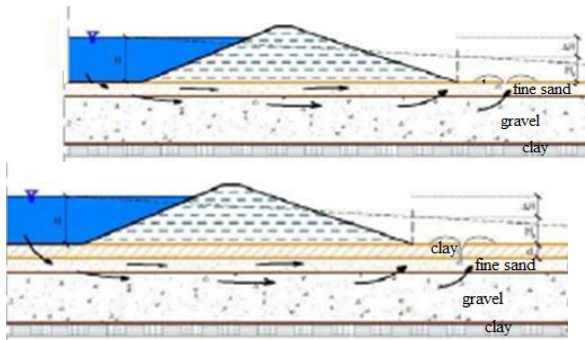
Figure 2. Layers leading to sandboils.

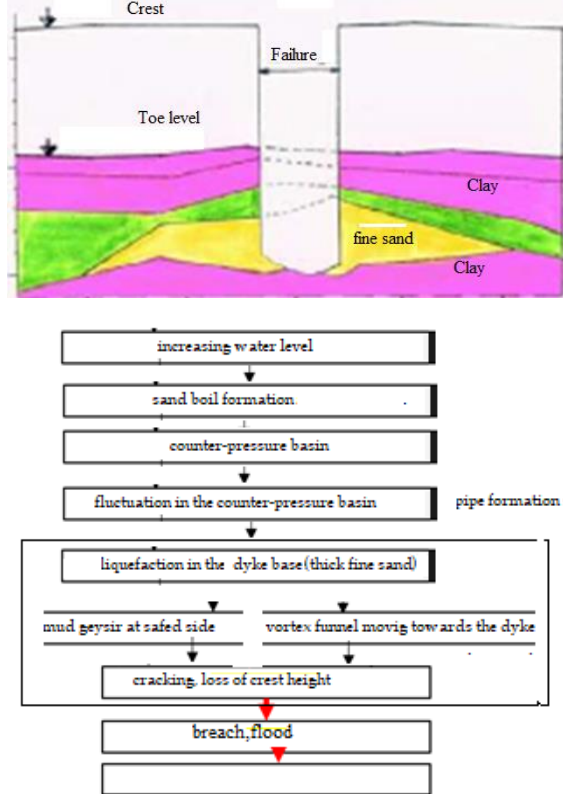
Figure 3. Layering leading to fast piping and possible fast piping scenario. It is a question if static liquefaction, dynamic liquefaction may occur or both.

The failure scenario was as follow. In the first days of the flood, small, usual sand boils occurred. Then the breach happened within minutes/seconds after the observation of the first mud geyser (at the place of the first sand boil) and simultaneously a moving vortex funnel towards the dyke in the river. The initial part with a normal sand boil may occur if no plastic cover soil layer is present.

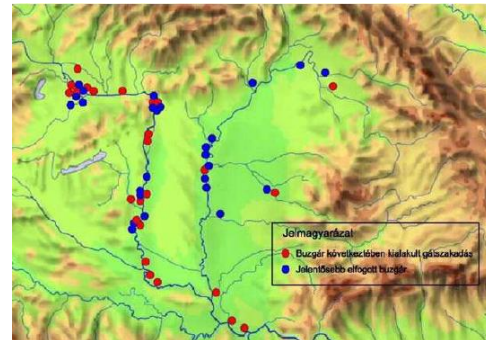
Figure 4. The big rivers and piping failures (red) and defended sand boils (blue) in Charpatian basin [6], [10] Nagy, 2014.

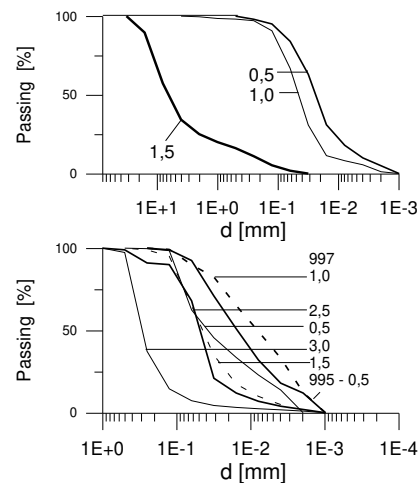
Figure 5. Grading curves for the (a) Dunakiliti soils and (b) the Dunalfalva soils. (c) and (d) Layers leading to sandboils.

Soil layers below the dyke were explored at two piping sites: at Dunakiliti and Dunafalva Figure 3-27. The Danube valley has a thick silty cover. A 0.5 m thick silt layer and a 0.5 m thick Mo layer were found above the sandy gravel layer at Dunakiliti (Mo is a soil category between silt and sand in earlier soil classification systems). Mo, silt, Mo and sand layers were found with a thickness of 0.6, 0.9, 1.3, 0.2 m, respectively, above the sandy gravel bad at Dunafalva. The grading curves are shown below.

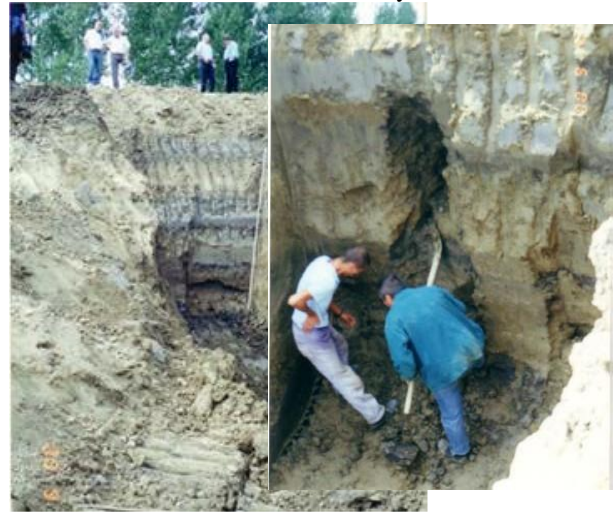
September. The cut through the levee showed the stratification and the path of the sand boil, which was first deep at the bottom and then it went up the waterside. Figure 3-29. shows the investigation and suggested that the sand boil occurred in a thick silty sand layer, which was covered with arched clay.

Figure 7. Opening of the sand boil

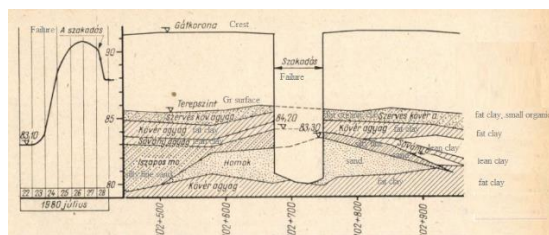
Figure 8. Kettős Körös river, Hosszúfok in 1980, fast piping failure, schematisation of subsurface at failure location.

The dam burst took about 5 minutes. The width of the tear grew rapidly, reaching a final width of 78 m. This was the first dam failure where detailed soil mechanical exploration was made afterwards

The evaluation: the piping mechanism is possibly liquefaction of the extremely loose and thick sand lens at the thickest dimension of the layer. The cause was assumed dynamic effect caused liquefaction. The possible dynamic effect was the tearing off the clay cover layer at the first geyser spot and the sudden displacement of the dyke body due to the increased horizontal load.

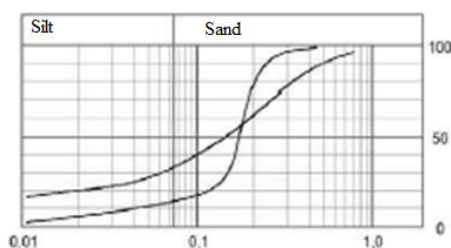
Figure 9. Kettős Körös river, Hosszúfok in 1980, fast piping failure, grading curves, indicating the very loose sand inclusion with $3 < Cu$ and $e \sim 0,8$ (Szepessy, J.(1983)).

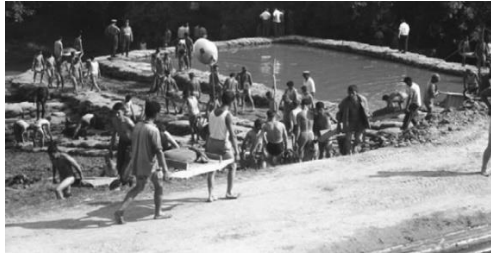
Figure 10. Danube, Margitta Island piping, counter-pressure and diaphragm walls at the waterside, the cause was the vicinity of an old meander, Horváth 2001
